## SUBARU

**Legacy Outback 01/2015 >> 03/2021**  
**Legacy Outback 04/2021 >>**

**Part No: SB-074-07U**

### Electric wiring kit for towbars / 7-pin / 12N / 12 Volt / ISO 1724

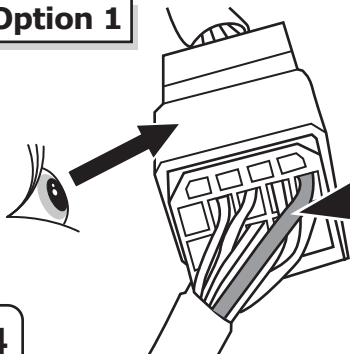
**Option 1**

Please check if **B+ /30** permanent power wire in trailer preparation connector has got a minimum diameter of **1,5 mm<sup>2</sup>**, continue with **Option 2!**

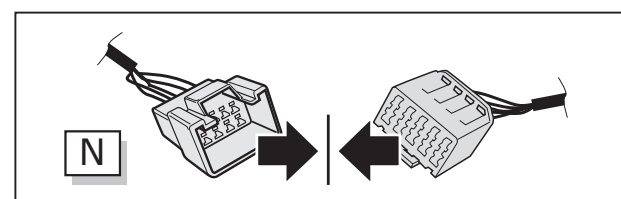
## **Option 1**

Please check if **B+/30** permanent power wire in trailer preparation connector has got a minimum diameter of **1,5 mm<sup>2</sup>**, if not please continue with **Option 2!**

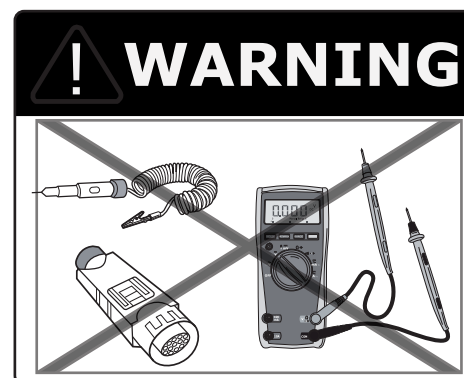
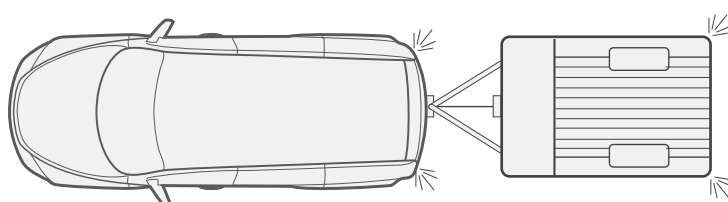
### Functional test

**TRAILER  
TEST DEVICE**

**ECS** part no.  
**TD001ZZ**

Please follow our instructions carefully and always test the towing electrics using a true lighting board or a specifically designed bulb tester. If an LED tester is used, ensure it is equipped with correct load resistors or malfunctions will occur!

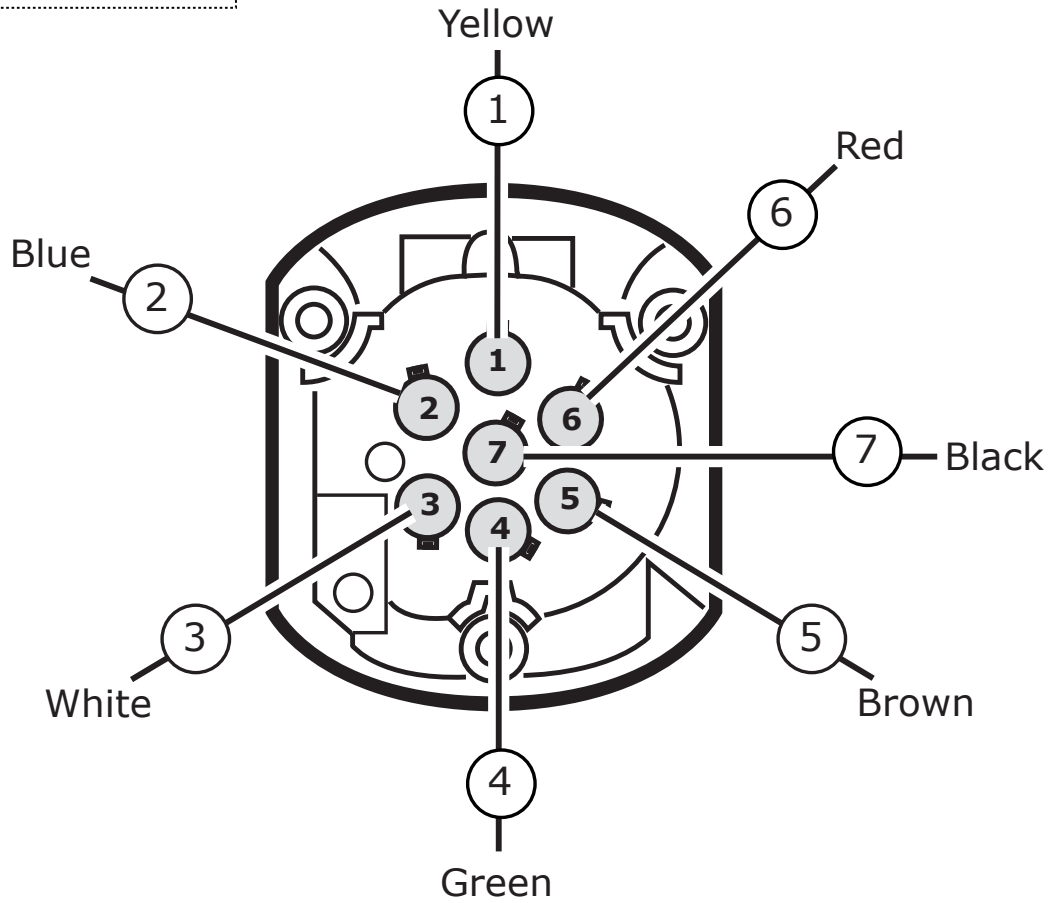
## SOCKET CONNECTION

| DIN/ISO<br>1724 | ← L | ⊕ | ⏚ 1-7 | R → | ☀ | ⊞ | ☀ |
| | 1/L | 2 | 3/31 | 4/R | 5/58-R | 6/54 | 7/58-L |
| Pmax | 21W | 21W | | 21W | 42W | 3x21W | 42W |
| | Yellow | Blue | White | Green | Brown | Red | Black |
