## SUBARU

**Legacy Outback 01/2015 >> 03/2021**  
**Legacy Outback 04/2021 >>**

**Part No: SB-074-13U**

### Electric wiring kit for towbars / 13-pin / 12 Volt / ISO 11446 **Fitting instructions**

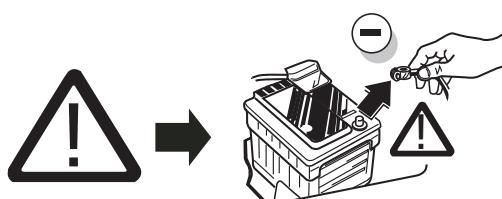
Note: It may be necessary to check if this vehicle has a stored radio code before disconnecting the battery!

**ATTENTION!** In order to avoid mal-functions and damage to the vehicle's electrical system the earth terminal **must be disconnected** from the vehicle's battery **before starting work!**

Both the trailer module and the vehicle's control unit for the electrical system can be damaged during work on the data bus connections if the battery is not disconnected!

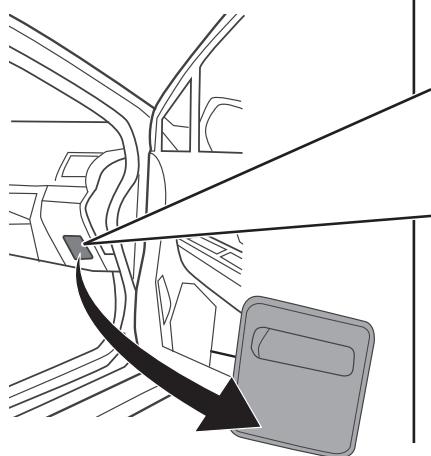
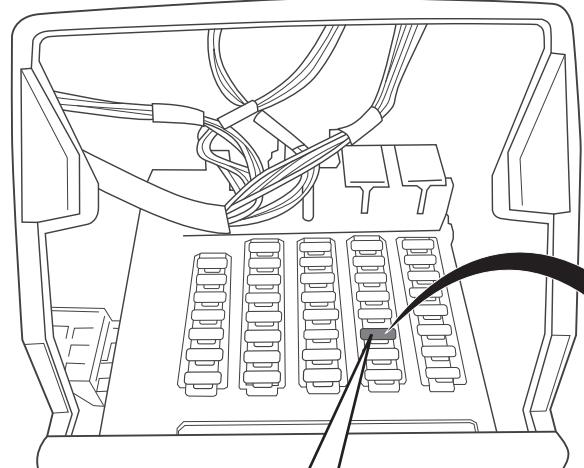
**46****33**

**Remove fuse!**

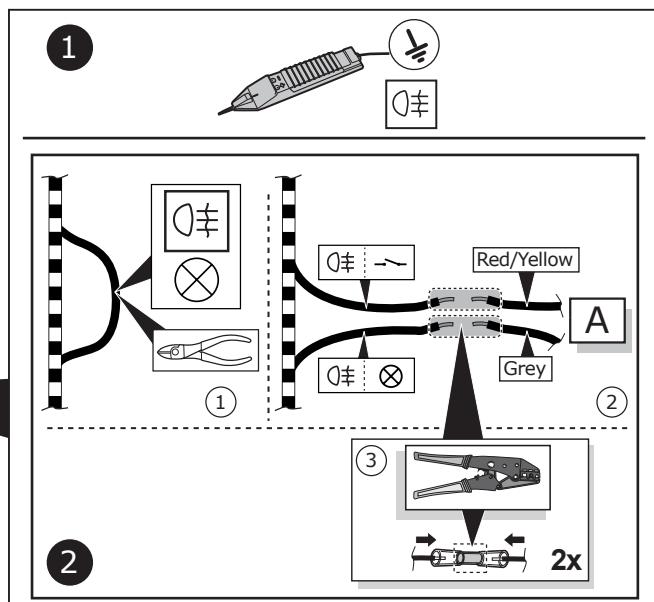
37

Please check if **B+/30** permanent power wire in trailer preparation connector has got a minimum diameter of **1,5 mm<sup>2</sup>**, if not please continue with **Option 2!**

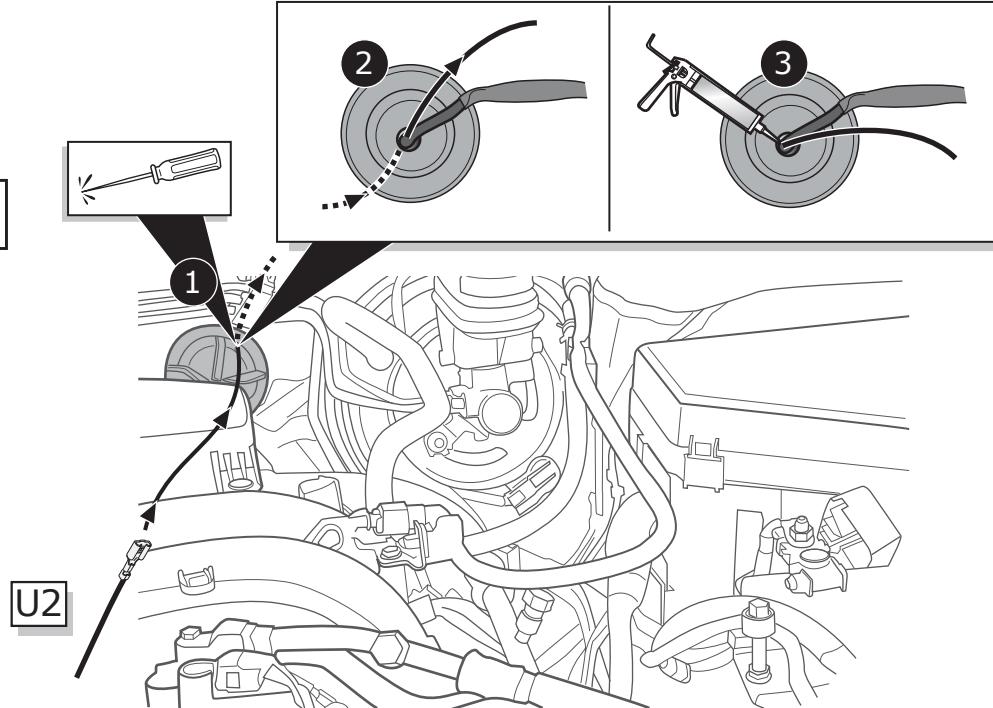
41

Do not damage  
OEM harness

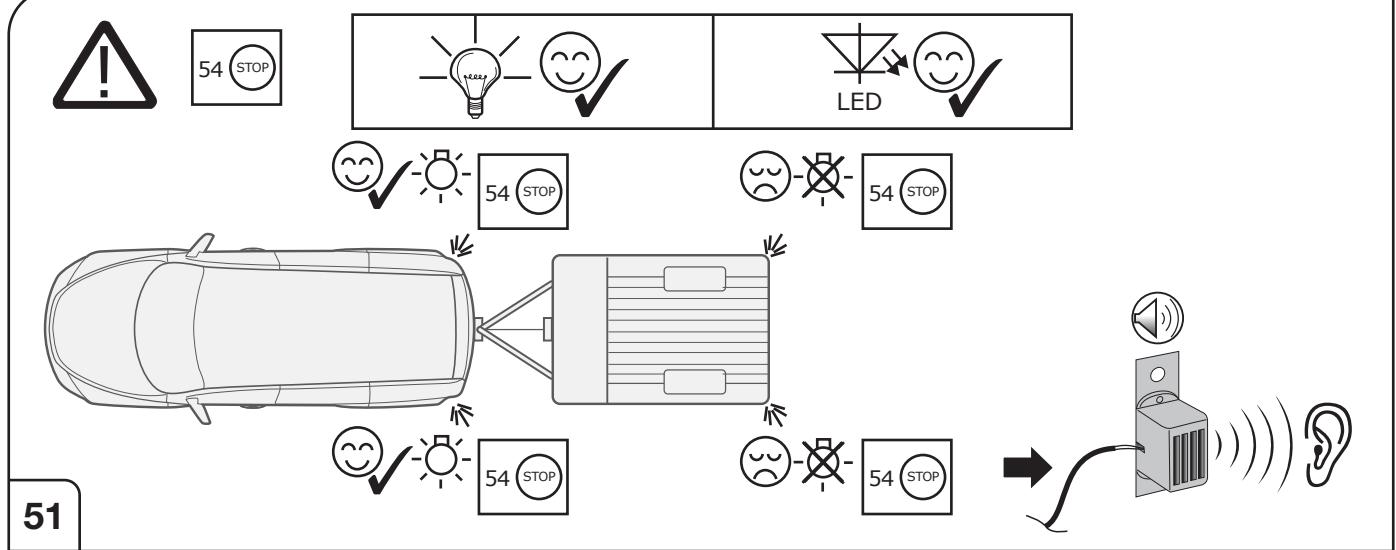
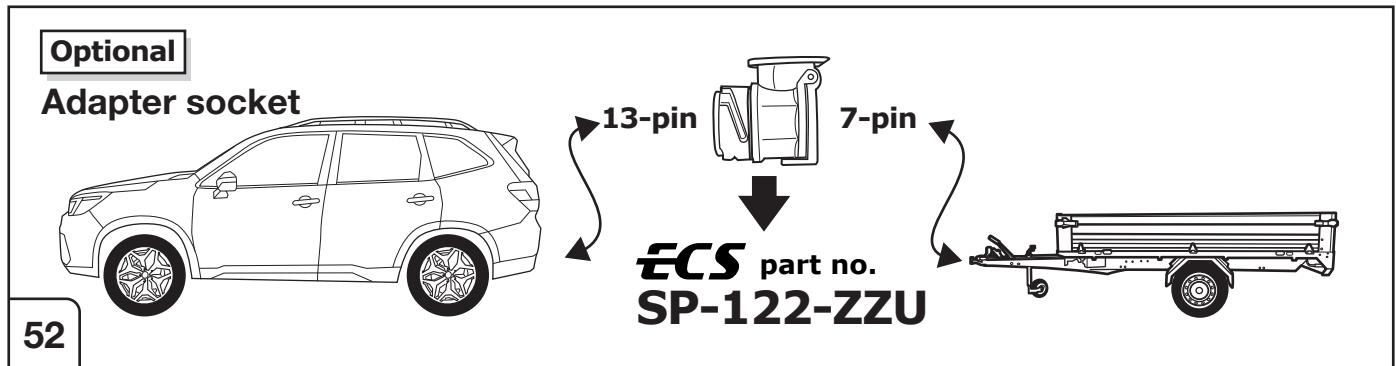
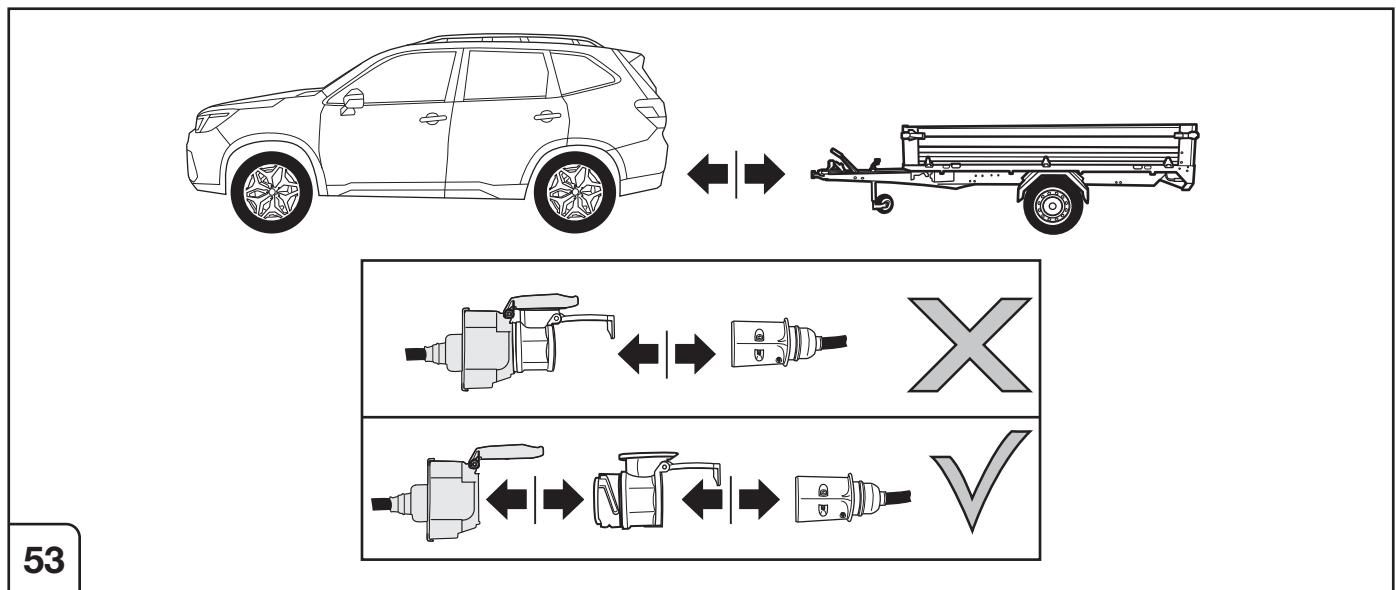
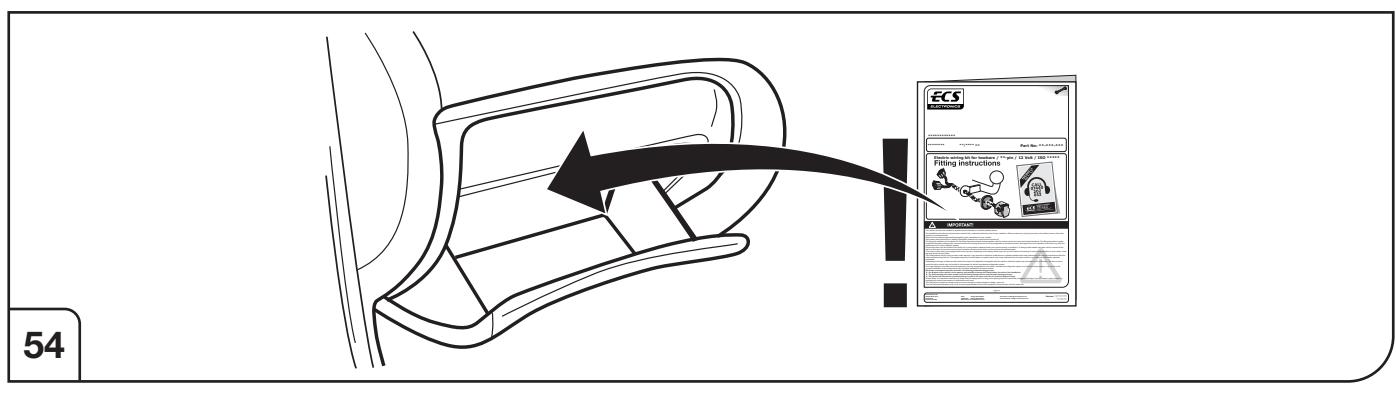
## SOCKET CONNECTION

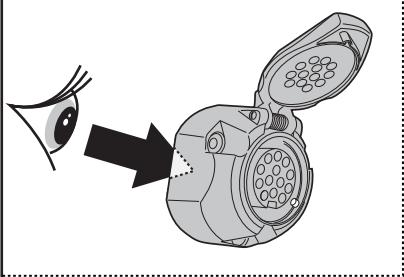
## SOCKET CONNECTION

DIN/ISO 11446														
1/L	2	3/31	4/R	5/58-R	6/54	7/58-L	8	Reverse	30+	15+	10	11	12	13
Pmax	21W	21W		21W	42W	3x21W	42W	21W	OPTION.	OPTION.				
Colour	Yellow	Blue	White	Green	Brown	Red	Black	Pink	Orange	Grey	White/Black	-	White/Red
