## SUBARU

**Legacy Outback 01/2015 >> 03/2021**  
**Legacy Outback 04/2021 >>**

**Part No: SB-074-07U**

### Electric wiring kit for towbars / 7-pin / 12N / 12 Volt / ISO 1724 **Fitting instructions**

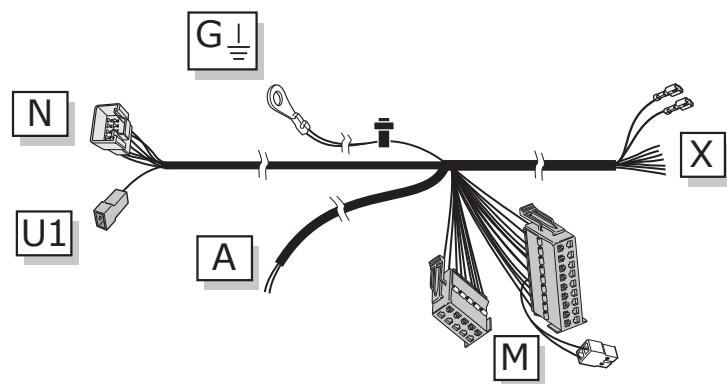
Fuse 20 Amp.

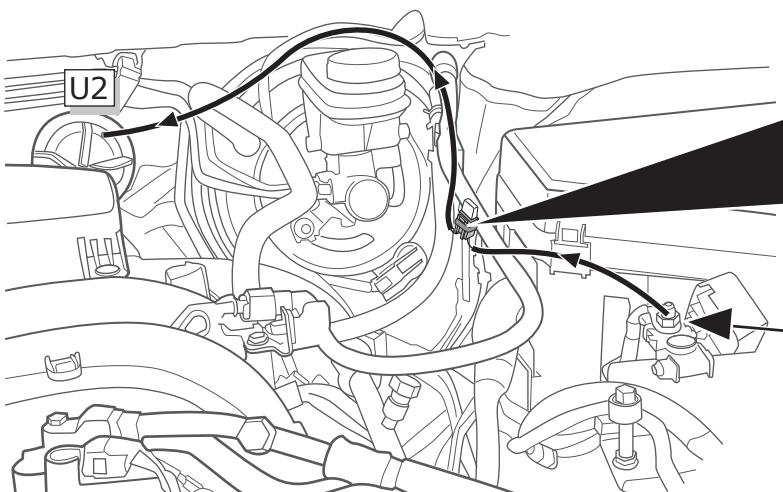
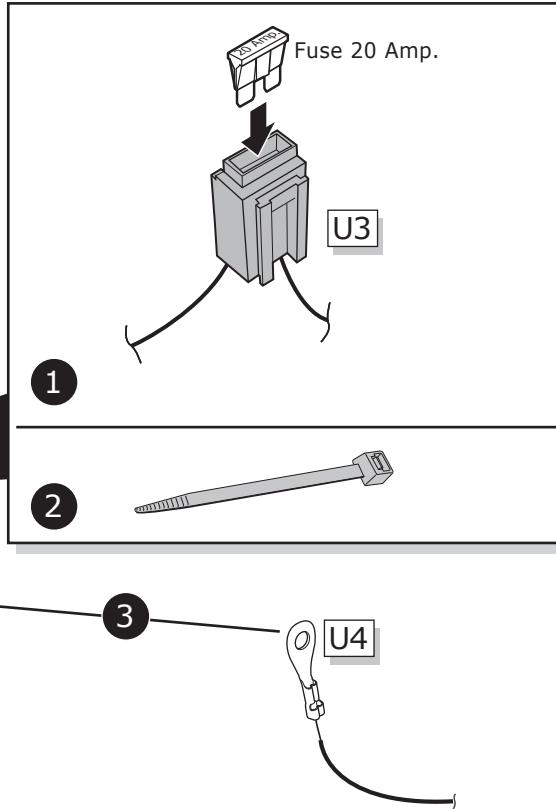
27

**Option 2**

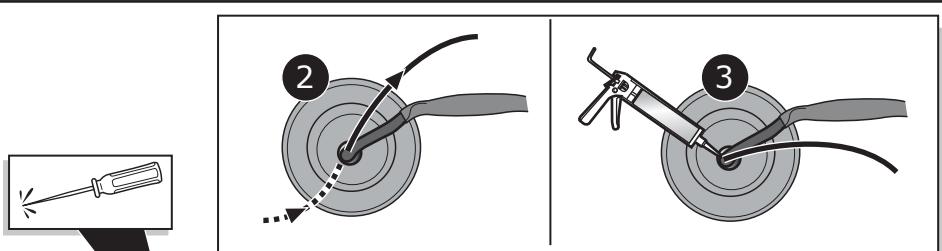
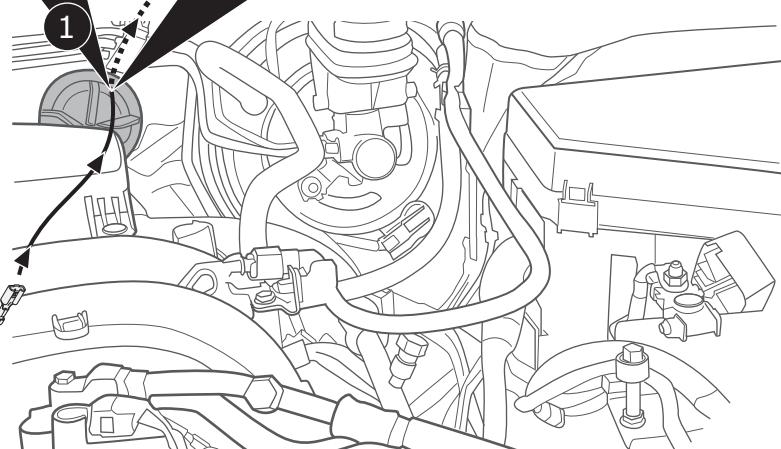
28

Do not damage  
OEM harness

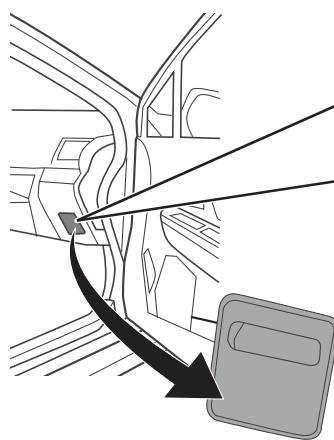
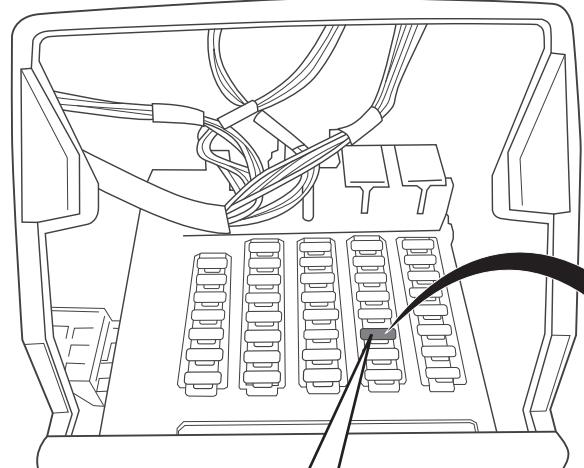
**Remove fuse!**

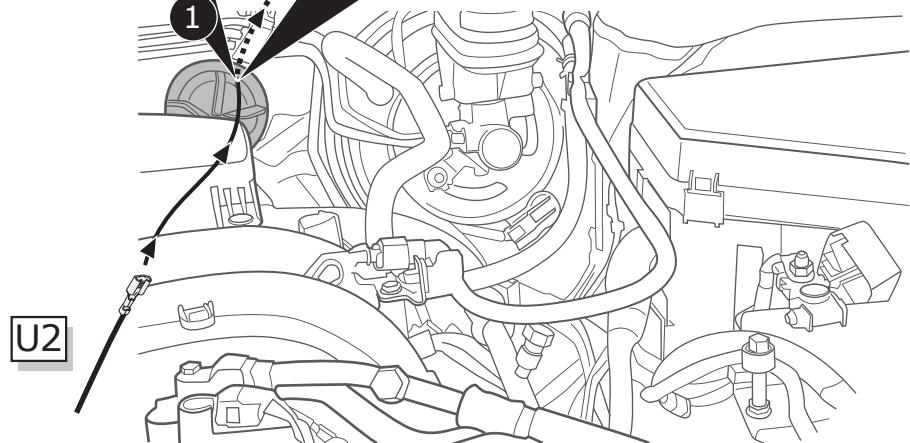
42

Do not damage  
OEM harness

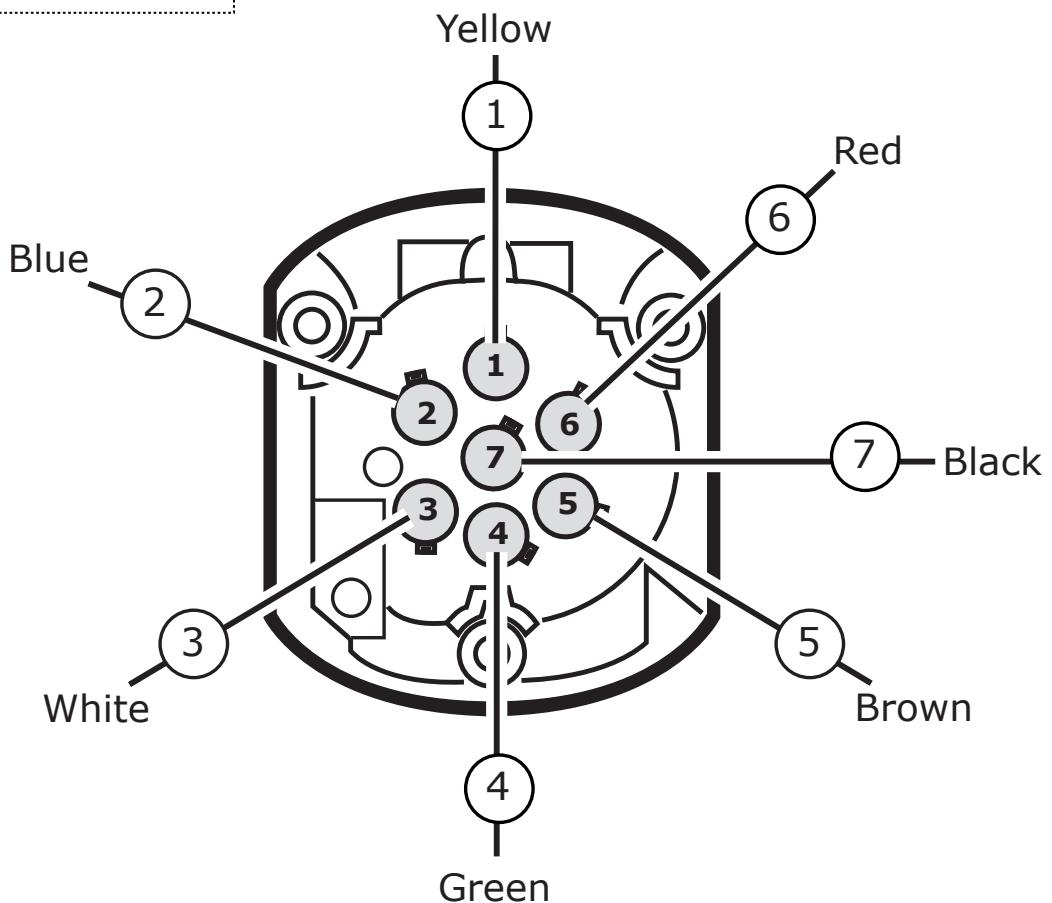
## SOCKET CONNECTION

DIN/ISO 1724	◀ L	0 0	1-7	R ▶	5 5	STOP	5 5
	1/L	2	3/31	4/R	5/58-R	6/54	7/58-L
Pmax	21W	21W		21W	42W	3x21W	42W
	Yellow	Blue	White	Green	Brown	Red	Black
